Engineering geological research of andesite alteration related to the revitalization of the Šášov Castle (Central Slovakia)

Abstract: An architectural study of the revitalization of the Šášov castle in the neovolcanic Štiavnické vrchy Mts. initiated a revision of the castle buildings. The building stone showed high post-volcanic alteration (hydrothermal and/or by weathering) or total disintegration in some parts of the walls. It must be replaced, because the safety of the ruins determines a sustainable development of this historical site. The castle hill rocks and the main building stone are both Neogene andesites, but not necessarily identical – the building stone came probably from several sources and the original source of the building stone was not the question. Suitable replacement material was searched for in a local quarry. Andesites at different weathering levels were taken to test the impact of alteration upon the rock properties and their suitability for the castle remediation. Expandable clay minerals were considered important for the rock weakening and weathering resistivity. Mineral composition was analysed by X-ray diffractometry. Powdered samples were used for the d

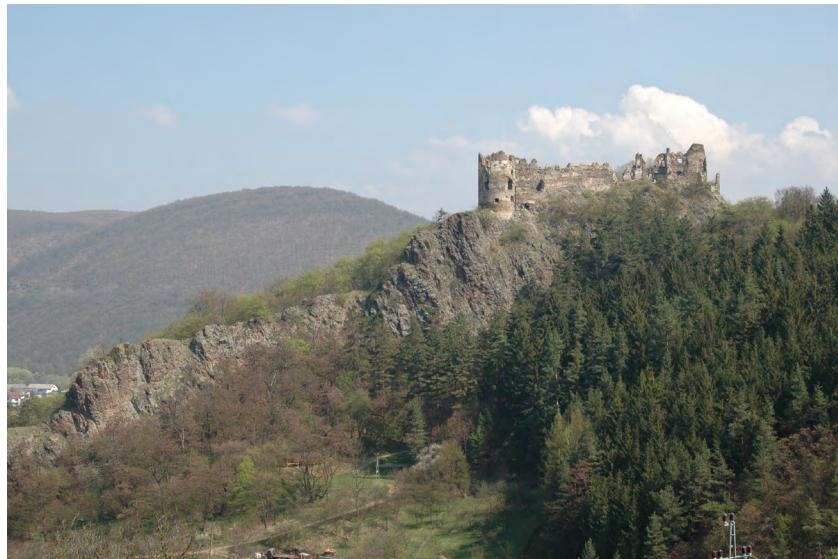
Fig. 1. South view of the Šášov castle ruins and the neovolcanic rock mass.

The medieval Šášov castle (Fig. 1) above the Šášovské Podhradie village (Central Slovakia, Fig. 2) is a national cultural heritage site. A strategic position on a hill overlooking the village and the Hron River was a reason for its construction. The most important dates in the castle history are: 1253 – early Gothic construction, 1490 – reconstruction and extension in the Renaissance style, 1677 – destruction in attacks, the castle turned into abandoned ruins (Hoššo, 1981). Since 1970 small rescue works were carried out. An engineering geological mapping of the castle rock mass in the scale 1:500, together with the inventory of the state of all castle buildings were done in 1994: some collapses of walls followed major tectonic lines in the castle rock mass opening due to slow slope movements, building stone and the binder were weathered (Vlčko et al., 1994). At the beginning of the 21st century an architectural study of the revitalization possibilities was presented (Adamcová, 2006) based on suggestive reconstruction and neoplasm, two basic methods used in architectural conservation. The reconstruction

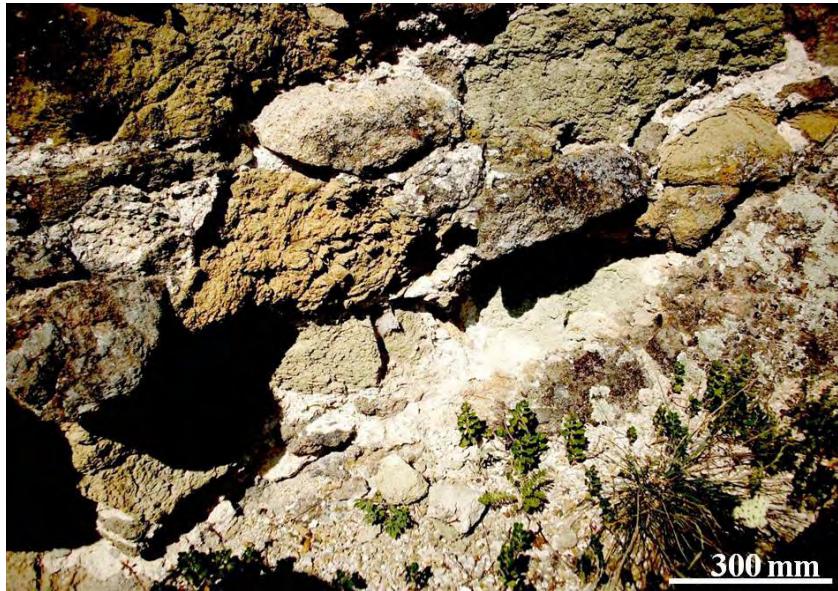
Fig. 4. Building stone of different alteration levels in the lower part of the wall: from color change to total disintegration, wall overhangs.
Obr. 4. Stavebný kameň v rôznom stupni alterácie v dolnej časti múrov: od zmeny farby až po úplný rozpad, previsy.

of the period style is impossible due to the lack of information about the historical architectural background, and the current unstable state of the ruins. The revitalization main idea is based on a legend about the first owner of the castle – a clown. The architectural study adapted this place to a new spot, where theatre, arts and nature meet through numerous stages for outdoor theatre and concerts, partly open air galleries, spotting places and view-points to “cheer up” the visitors (Fig. 3). It tried to avoid solutions, where the existing ruins would serve as a holding base for new constructions. Own carrier systems should be fully independent from the ruined walls and only “inserted” into the existing ruins. In spite of this, a professional conservation of the remaining walls cannot be avoided, so a brief revision of the castle condition was done in 2009, 15 years after the inventory. The most dramatic destruction was found in the so called Round Tower: a seriously cracked wall over a tensile joint in the rock mass collapsed. But in general, changes in the wall crowns were quite negligible. All levels of weathering were present in the lower wall parts (Fig. 4-5), leading to cavities and overhangs. A characteristic macro-porosity of the weathered building stone was observed, too.

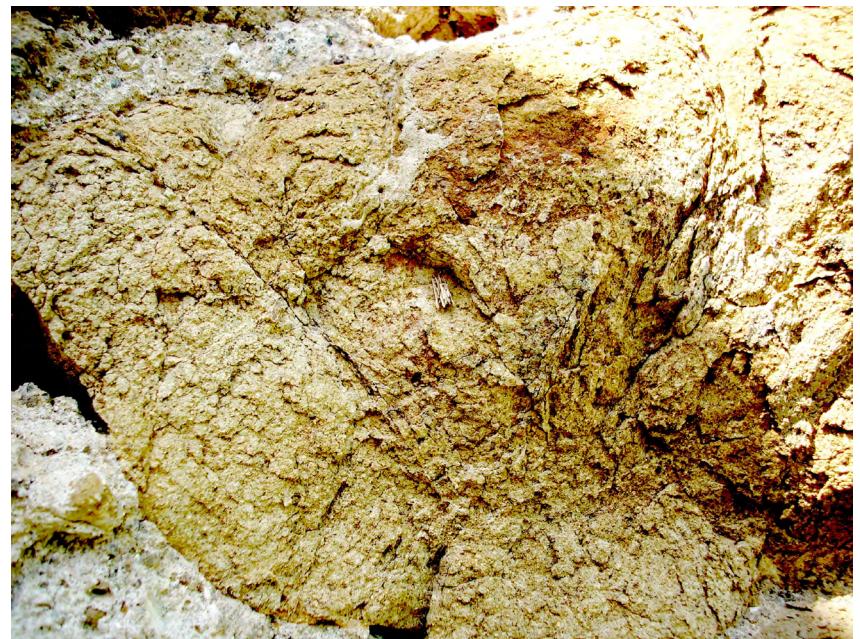
Fig. 5. Highly altered building stone: yellowish color, disintegration into small grains along many fine cracks. Length of the block ca. 500 mm.

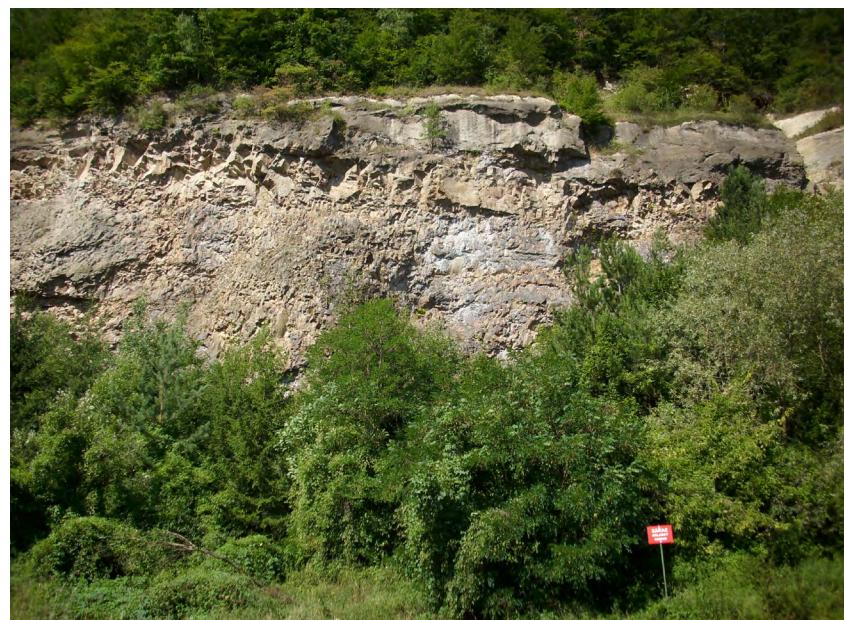
Fig. 7. The potential source of the replacement building material – an old local andesite quarry. Gradual transition of the massive pyroxene andesite upwards into porous blocky lava breccias with a cover of pyroclastic rocks the top.

that a certain part of the building stone comes from the quarry due to the short distance. Samples showing different alteration levels were taken from the castle (1 relatively sound and 1 highly altered and disintegrated) and from the quarry (4 levels, from sound to “altered III”) to test the impact of alteration upon the rock properties and the suitability for the castle remediation (Fig. 7-9).

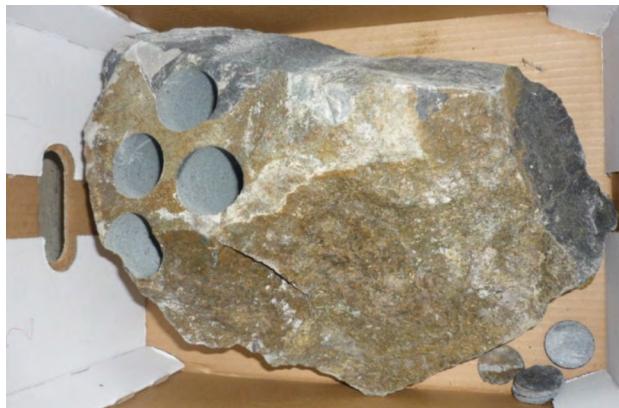
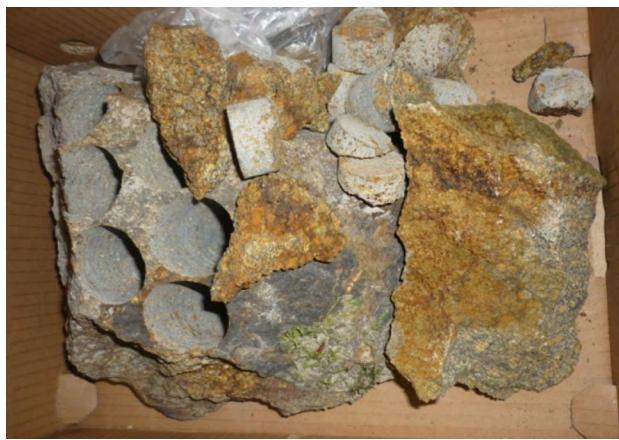
Fig. 8. Quarry andesite blocks: relatively sound on the left, altered II on the right. Drillholes diameter is 34.75 mm.

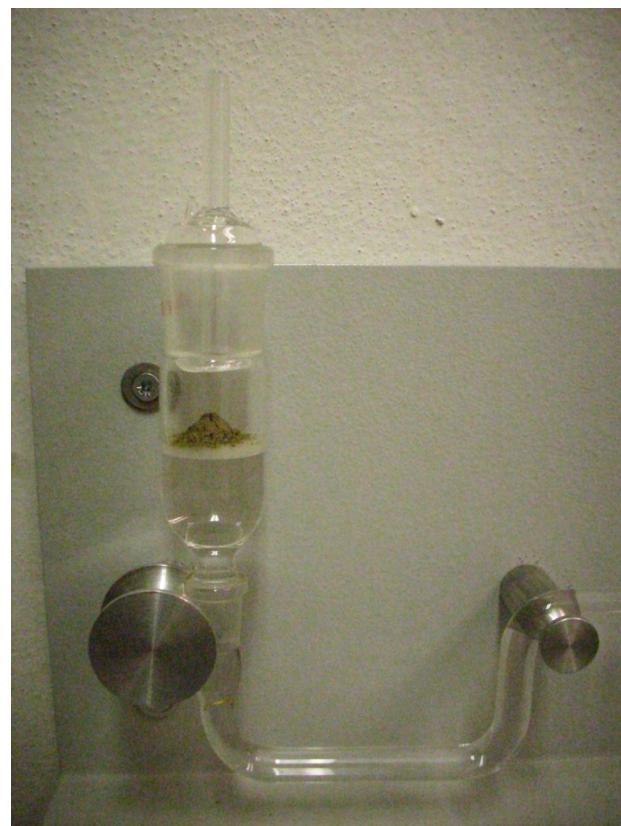
Fig. 10. Enslin-Neff test. Conus of the rock powder in the center of the water-saturated porous plate enabling suction and absorption of water.
Obr. 10. Skúška Enslin-Neff. Kužeľ horninového prášku v strede frity nasýtenej vodou, ktorá umožňuje vzlínanie a absorpciu vody.
