Reactivation of fossil landslides during motorway construction in overconsolidated Neogene sediments

Miloslav Kopecký^{1*}, Jakub Panuška¹, Jana Frankovská¹ & Martin Ondrášik¹

¹ Department of Geotechnics, Faculty of Civil Engineering, Slovak University of Technology in Bratislava Radlinského 11, 810 05 Bratislava, Slovakia; miloslav.kopecky@stuba.sk

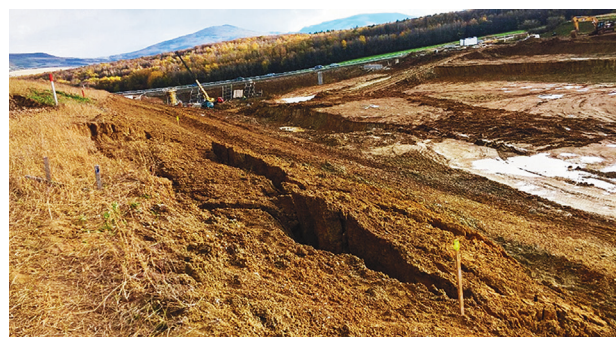
Fig. 4. Active landslides at 10.775–10.8 km (date: 25.10.2017).

changes. Fig. 3 shows a simplified geotechnical profile 1 of the cut at km 10.775. The road cut was initially designed with a slope of 1:2.5. Anchored concrete beams at the foot of the cut were designed to increase the stability of the cut. The cut was excavated from km 10.8 to km 11.0. With a gradual excavation of the cut to a depth of about 12 m, landslides developed, especially on the left side in the direction of alignment (northeast). At the 10.75–10.8 km section, an active landslide with a total area of about 25 × 25 m occurred on the left side (Fig. 2). The head scarp reached a height of 2.2–2.5 m, while the tensile cracks reached a depth of 3.0 m from the edge of the modified slope (Fig. 3 and 4).

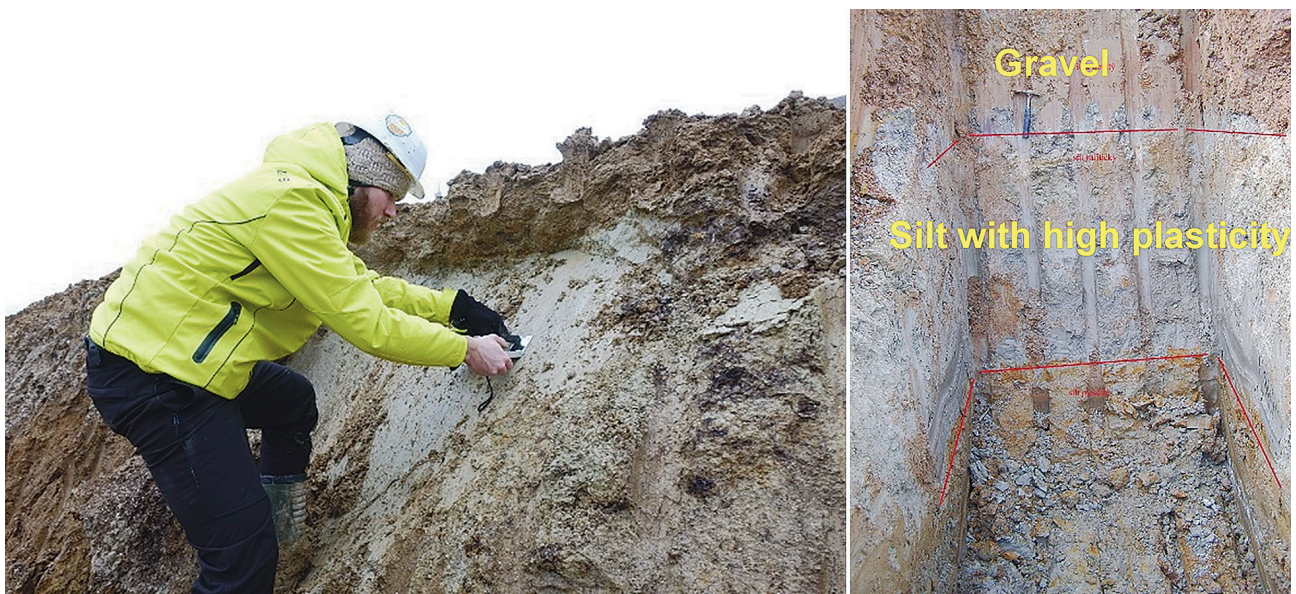
Fig. 6. Slip surfaces in the excavation of the cuts and the excavated shaft.

observed in laboratory tests, as it will be discussed later in the article. The layers of these clays is located irregularly in several places on both sides of the cuts (see Fig 2/3, MH soil). Such disintegration is the evidence of micro layering and micro cracks in Neogene soils. Smooth and shiny slip surfaces in the clay layers and shallow landslides were recorded during the construction site inspection of exposed parts of the road cuts (Fig. 6).

A layer of gravel above the slip surface is typical for this locality. This structure was confirmed in many excavated shafts on the base of the temporary road cut excavation (Fig. 6). Investigation shafts were excavated on both sides of the road cut. In Fig. 7 the vectors of the direction of inclination of the assumed shear surfaces in the shafts are presented. Although these are point values - a certain connection can be found in the spatial distribution of

In addition to shallow landslides on the surface of the cut slopes, there were visually identified other smoothed shear surfaces in the bottom part of excavation (Fig. 6). These shear plane dedicated the presence of old fossil landslides.

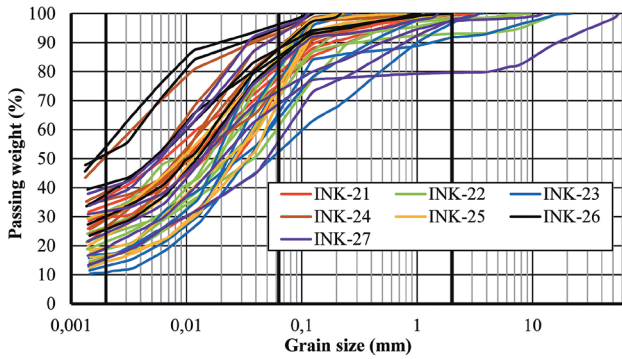
Fig. 8. The grain size distribution of the ground samples.

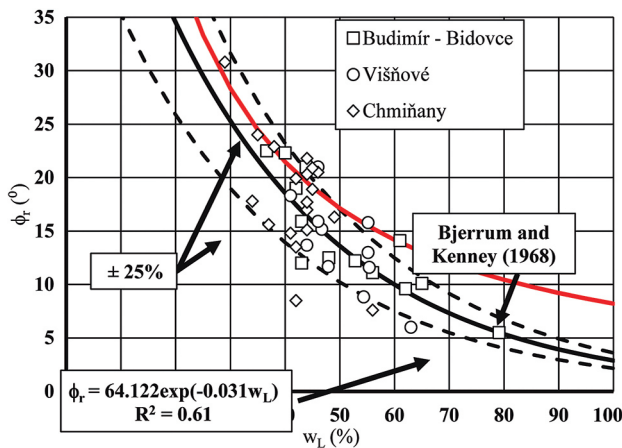
Fig. 9. Relationship between ϕ_r and the liquid limit (w_L) for the samples from three different localities of the motorway construction (Budimir, Višňové, Chminany) in comparison with relationship from the literature (red line).

two others, were used in the analysis. A set of 43 values of the residual angle of internal friction (ϕ_r) used for calculation is presented in the summary graph of the relationship between ϕ_r and the liquid limit (w_L). The red line in Fig. 9 is the correlation from the literature.

Considering the relationship in Fig. 9 and the hypothesis about critical shear surface development in highly plastic clays, the range $\pm 25\%$ of residual internal friction angle with $w_L = 65\%$ was determined to be from 6.9° to 11.5° . The average residual angle for samples of high-plasticity clays from the investigated locality was defined as $\phi_r = 10.4^\circ$. Based on these values, the design value, verified by back analysis of slope stability, was $\phi_r = 8.5^\circ$.

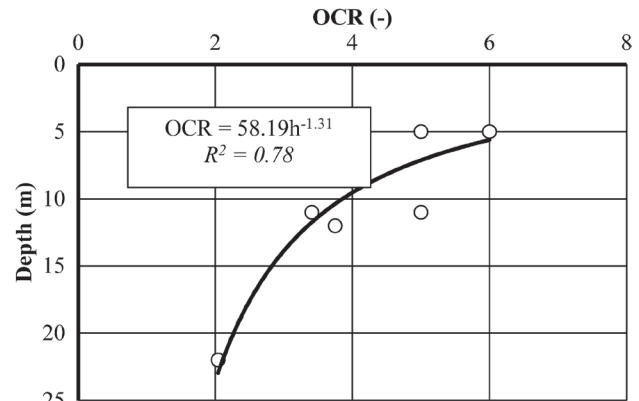
Fig. 10. Variation of overconsolidation ratio (OCR) with depth from laboratory testing of samples in the boreholes INK-21 to INK-27.

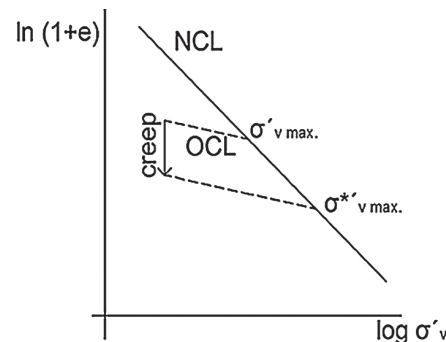
Fig. 11. Failure at OCR determination due to creep (according to Boháč et al., 2013).

The effect of the creep can lead to the indication of false overconsolidation pressure (Powrie, 2004) as indicated in Fig. 11. Due to these findings and the absence of other testing (e.g., field tests), the OCR value was considered to be 3.5 for soils affected by the cut and 1.5 for soils below the bottom of the designed cut.

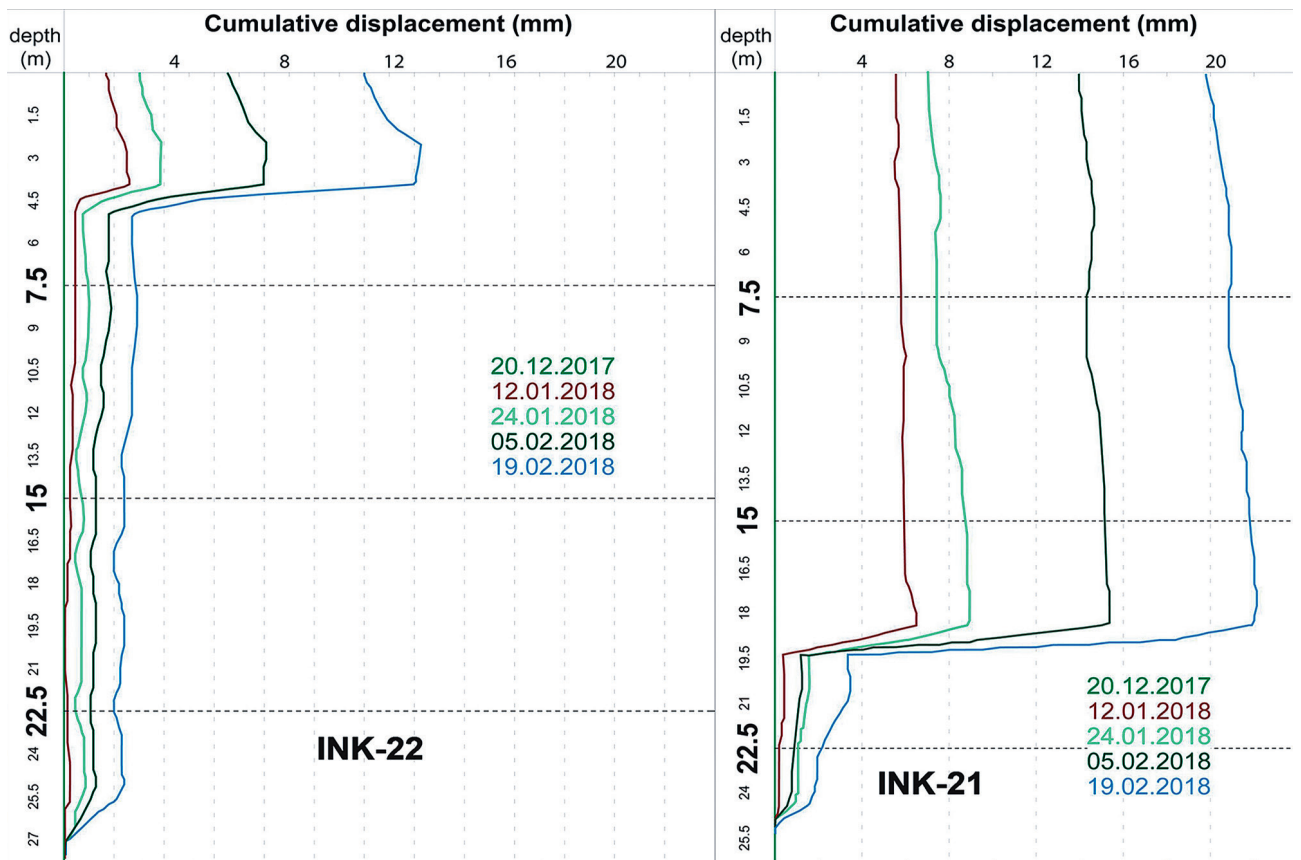
Fig. 13. Cumulative displacement curves obtained by the inclinometers INK-21 and INK-22 in the road cut for the period from December 2017 to February 2018.

borehole. Tests are conducted at regular depth intervals (usually 0.5 m) in two orthogonal axes with automatic determination of azimuth. Repeated measurements allow high accuracy and reliability to determine the speed of movement, depending on the time intervals between the individual measurements. The monitoring system consisting of 2 inclinometers was supplemented with seven inclinometers (INK-21 to 27) in the entire road cut excavation after the shallow landslide occurring (Fig. 4). The first control measurements on inclinometric boreholes in January 2018 verified the movement in the INK-22 inclinometer, located just above the head scarp of the active landslide (Fig. 3). The movement was recorded at a depth of about 3.7 m (Fig. 13) and had an accelerating character. The detected depth of movement corresponds to the shape of the slip surface of the active landslide. Movement in INK-21 also had an accelerating

tendency. Inclinometers INK-21 and -22 were monitored weekly. Motion at INK-21 continued at a constant rate of 14 mm/month; at INK-22 the rate increased slightly to 11 mm/month.

The most important information about the global stability of the cut slope was that in the inclinometer INK-21 (km 10.85), where there was a movement on the slip surface at a depth of about 17.7 m (Fig. 13), which would correspond to the contact of clayey gravel with high-plasticity clays. The old, weakened failure surface was activated. The instability on the slope occurred in a partially excavated cut (blue line in Fig. 14). Until the execution of the final shape of the slope of the cut, another 7 m remained to be excavated. A new inclinometric borehole, INK-29 and INK-28, were installed to verify the course of the slip surface on the left side (northeast) of the cut in March 2018 (Fig. 2).

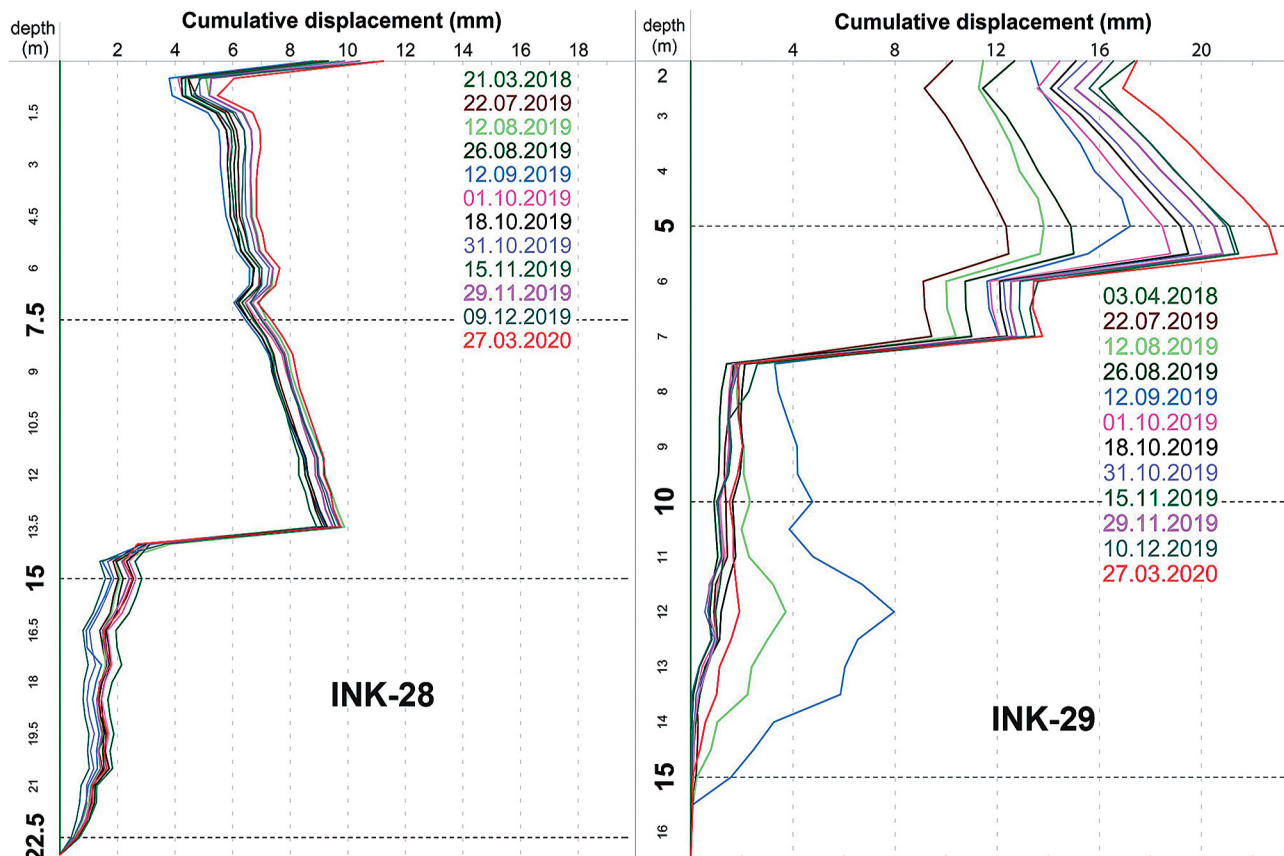
Fig. 15. Cumulative displacement curves obtained by the inclinometers INK-28 and INK-29 in the cut.

A slip surface at 7.0 m depth was found in INK-29 (Fig. 15) after the first measurements. A slip surface at a depth of approximately 13.5 m was detected by monitoring the INK-28 (Fig. 15).

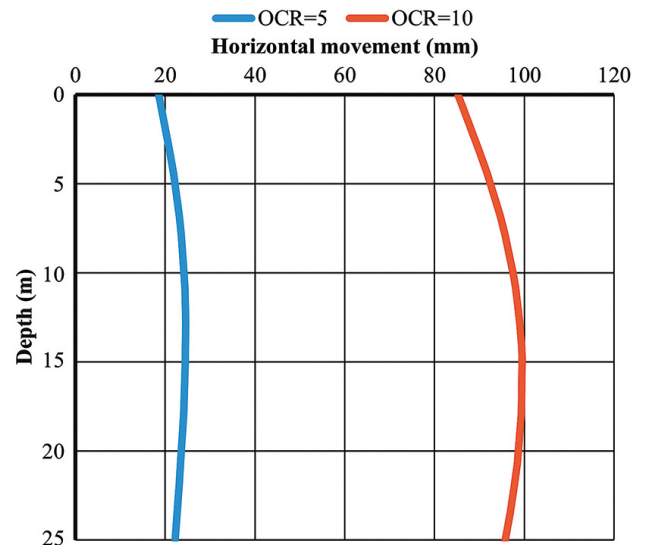
Fig. 16. Horizontal deformations after excavation in the cut slopes with OCR = 5 and OCR = 10.

In the case of overconsolidated high-plasticity clays, large horizontal stresses were released during the excavation of the cuts. Increased horizontal pressure at rest is the result of overconsolidation (Mayne & Kulhawy, 1982). When stress is released, both horizontal and vertical deformations and volumetric deformations occur. These results in microcracks, which create a path for the infiltration of water into the soil mass and thus a change in its water content. Most soils are in a narrow grain size range, and almost all samples contain a sand fraction of 5–40%. Such soil with a significant silty fraction is not impermeable and the value of coefficient of filtration is in the range $k = 10^{-9} - 10^{-7} \text{ m/s}$. This means that soils will relatively easily absorb water from precipitation or melting snow, which will increase the pore pressures in the ground. The increase in moisture and contact with water also causes further development of microcracks, increase in porosity, and progressive degradation of soil structure. The consistency changes to a soft or liquid one, showing markedly viscous behaviour. This phenomenon is mostly related to presented shallow landslide. The influence of OCR and horizontal stress release on the formation of sliding structures were analysed on a simplified model using a parametric study. The model used was the hardening soil model. In both models, the tensile strength of the ground was 5 kPa. The resulting factor of safety was about 1.42. For the stability analysis, the $\phi - c$ reduction method was used, where the shear strength parameters are gradually reduced until failure is achieved. While the significantly different deformations were achieved for different OCR values (Fig. 16) the resultant factor of safety was not changed.

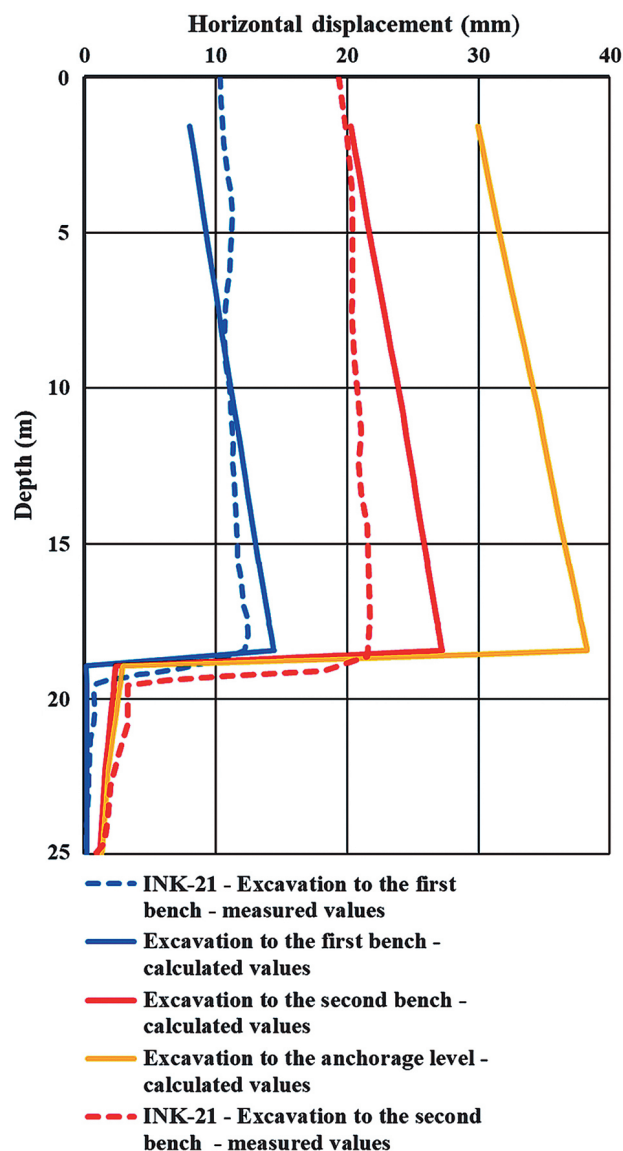
Fig. 19. Deformations around INK-21: measured values in geotechnical monitoring and data from FEM modelling.

Deformations at the INK-21 site from the FEM analysis were compared for the individual phases of excavation up to the current state with the measured displacement in INK-21 during the geotechnical monitoring. Results are shown in Fig. 19.

The deformations at the INK-21 site from the FEM analysis are presented in Fig. 19. Deformations without landslides were subtracted from deformations with a landslide, so that only the increase in landslides without the effect of unloading of the soil mass was obtained. The total deformation from the beginning of excavation until the cut was made at the second bench (the start of the monitoring) was almost 40 mm on the shear surface. The excavation to the anchorage level was about 10 mm (approximately the current movement in INK-21). The analysis of the section at 10.85 km showed that the left-hand cut (northeast) could not be realized according to the design and appropriate remedial actions were designed. These remedial actions were protection of slopes against climate effects. Additionally, anchored pile walls were designed in order to stabilise deep landslides.
