# Human-induced landslides in the Angren coal district, Uzbekistan

**Key words:** slope deformation, human-induced landslide, Angren, geoaoustics, radar interferometry, monitoring

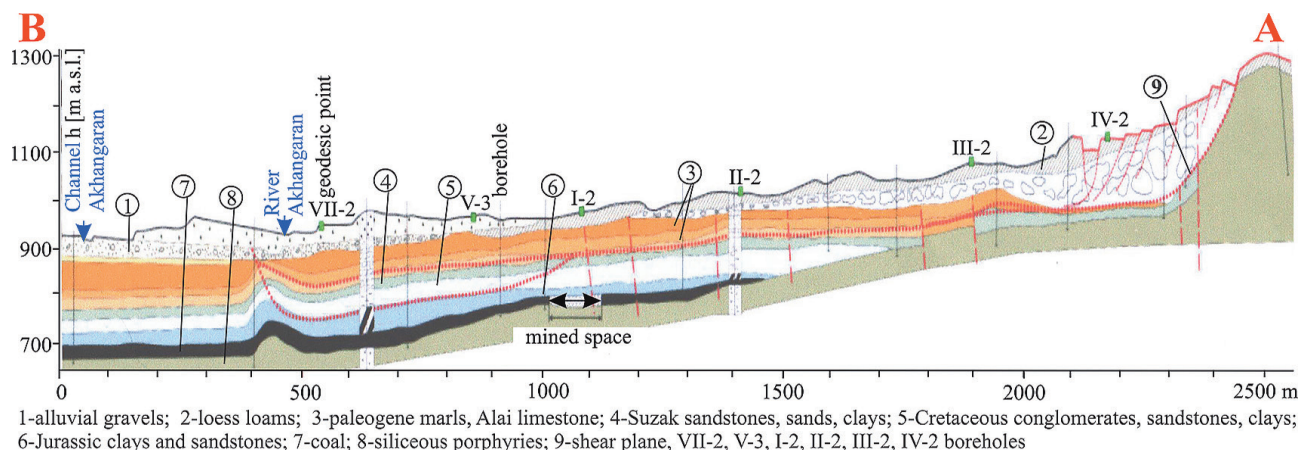
Fig. 3: Geological cross-section through the left slope of the “Akhangaran” (profile location see Fig. 6)

stable and moderately weathered. The Suzak Stage is 10–40 m thick, composed of sandstones, gravel clays and conglomerates with sandy-marly clays (Fig. 3). The hydrogeological conditions in the Angren coal pit are distinguished by four groundwater-

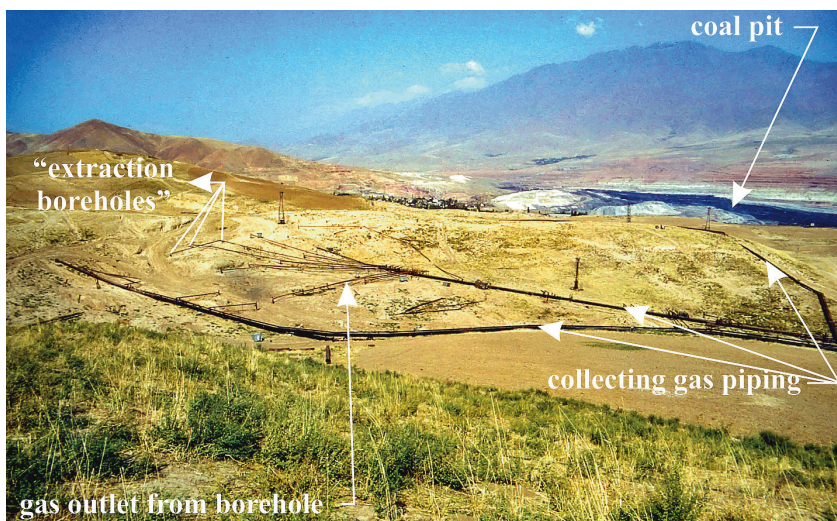
Fig. 5: View of “extraction boreholes” and gas piping

a part of the landslide with “extraction boreholes” and gas piping is in Fig. 5. The first movements were detected in March 1971.

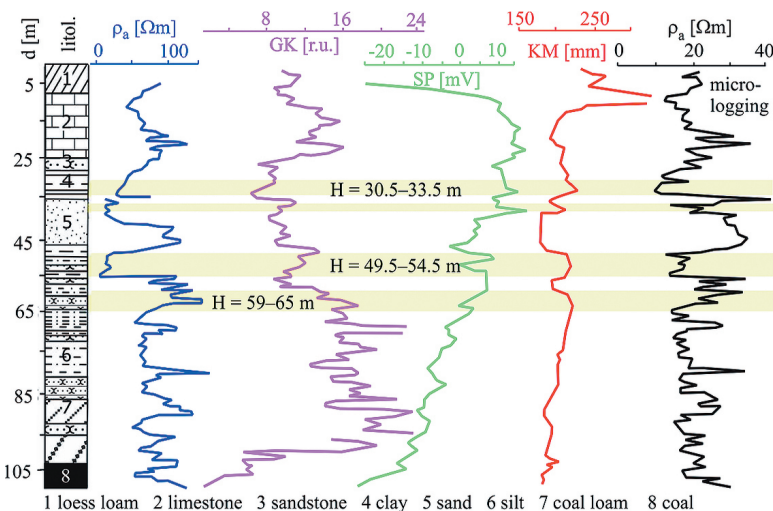
Fig. 7: Down-hole logging on the "Atchi" landslide

complicated geological structure of the investigated area. In the engineering-geological survey of this slope deformation, geophysical methods were also used, both ground-based and drilling. The ground-based methods included resistivity methods and the method of spontaneous polarisation. The down-hole logging methods comprised only the methods available in Uzbekistan at that time, i.e. the method of natural gamma radiation, the resistivity methods (potential probe and micro logging) and the measurement of the borehole diameter. The analysis of each curve has shown that it is possible according to the drop in apparent resistivity and the reduction of the borehole diameter to measure zones in which the rock mass is being fractured (Fig. 7).

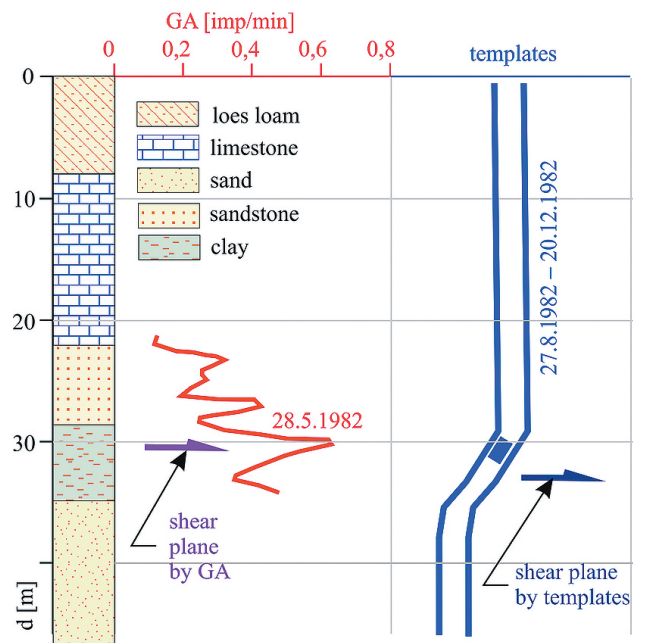
Fig. 8: Results of geoacoustic measurements

The Czech geophysicists carried out geoacoustic measurement in a borehole (borehole depth – 50 m, drilled 1982) which was prepared by the Uzbek party. The drilled borehole was fitted with plastic casings and the space between the borehole wall and the casing was filled with clay-cement slurry. The methodology of geoacoustic measurements was the same as used in Czechoslovakia. After the first installation of eight sensors in the borehole, a resting time was left in the duration of 12 hours (Bláha, 1996). The resting period after relocation of geophones was 60 minutes, the same as the time of measurement. The borehole could be measured only from 21 metres down because the drilling crew was not able to seal sufficiently the casing string. The evaluation of geoacoustic measurements in the form of the frequency of pulses showed that the rock mass was stressed 28 to 34 metres around the borehole while it began to be fractured at a depth of 30 metres (Fig. 8). If we compare this depth with the first two

zones of fracturing from down-hole logging, then we must state that a good agreement of indirect methods in assessing the state of the rock mass. The time showed that the fracturing of the borehole predicted from geoacoustic measurements had been justified. The borehole was cut by slope movement at this depth in about seven months according to the measurement of the passability of the borehole.

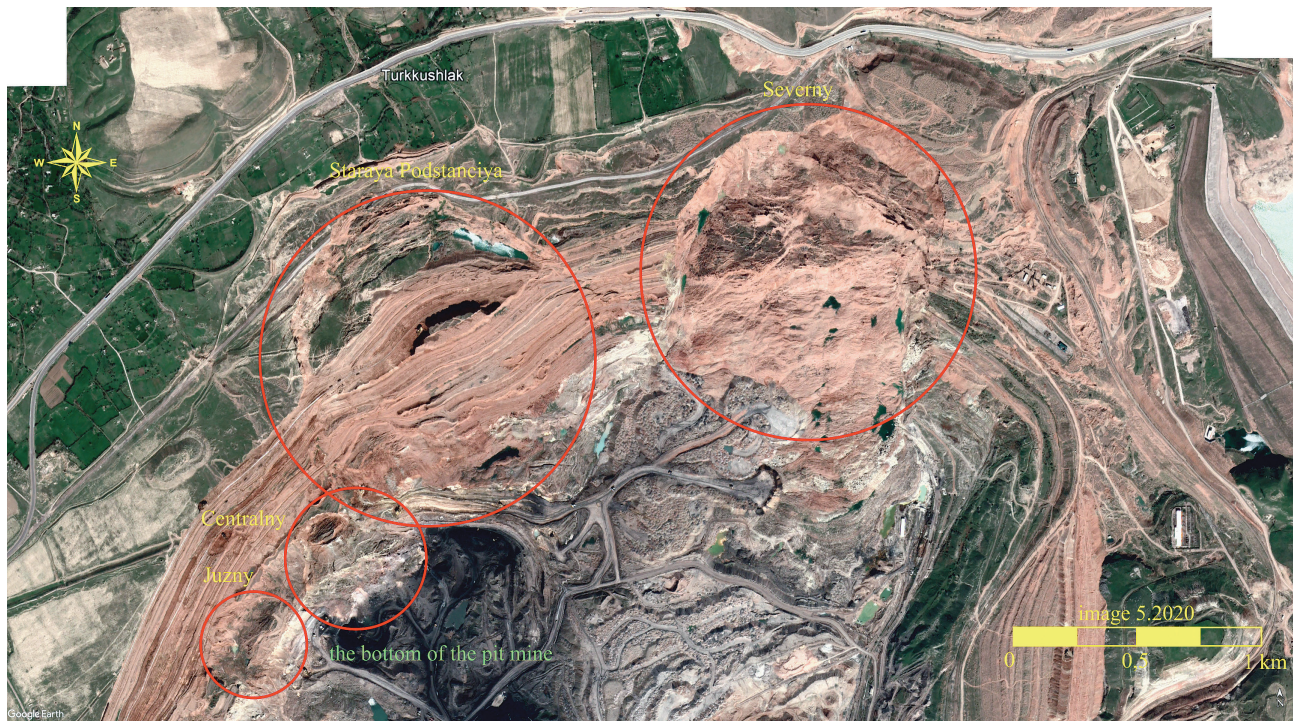
**Fig. 10: Slope failures on the north and northwest walls of the pit**

in the above-mentioned places of the pit are depicted with names in Fig. 10. Fig. 11 shows a conventional map of such landslides.

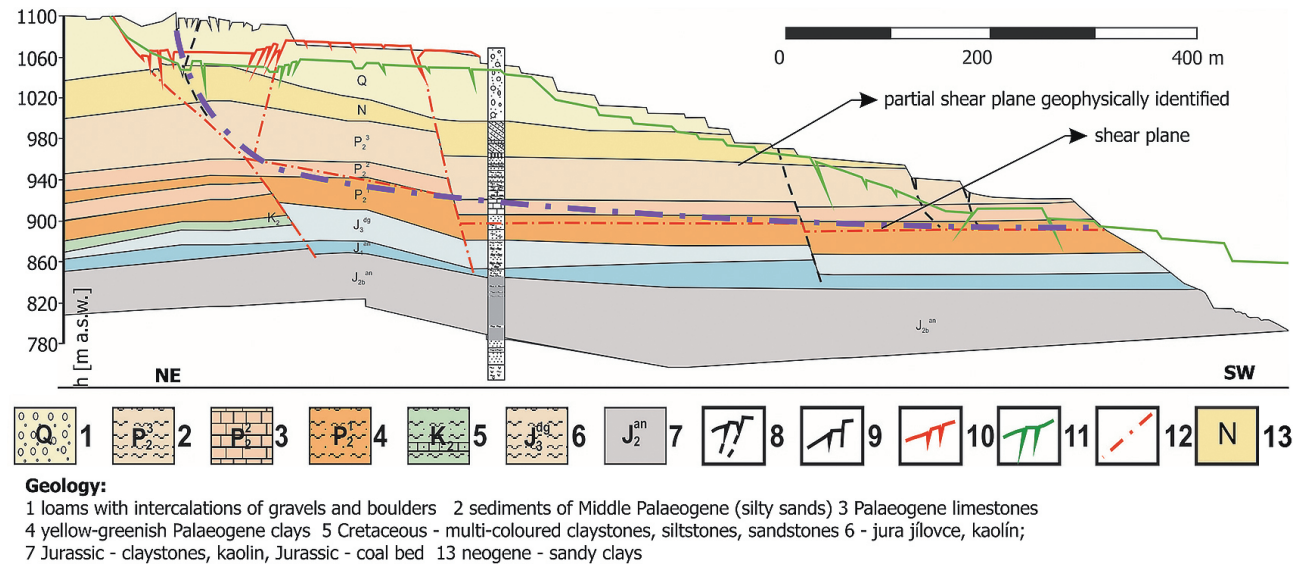
Fig. 14: Geological cross-section through the „Staraya Podstanciya“ landslide (profile location see Fig. 17)

Fig. 14 shows a geological cross-section through the landslide. Based on the investigation by Uzbek engineering geologists, shear planes mostly “remain” in younger rocks; they are found in the rocks of Jurassic age only rarely. Fig. 15 shows the latest satellite image of the “Staraya Podstanciya” landslide. The image is dated 2 May 2023.

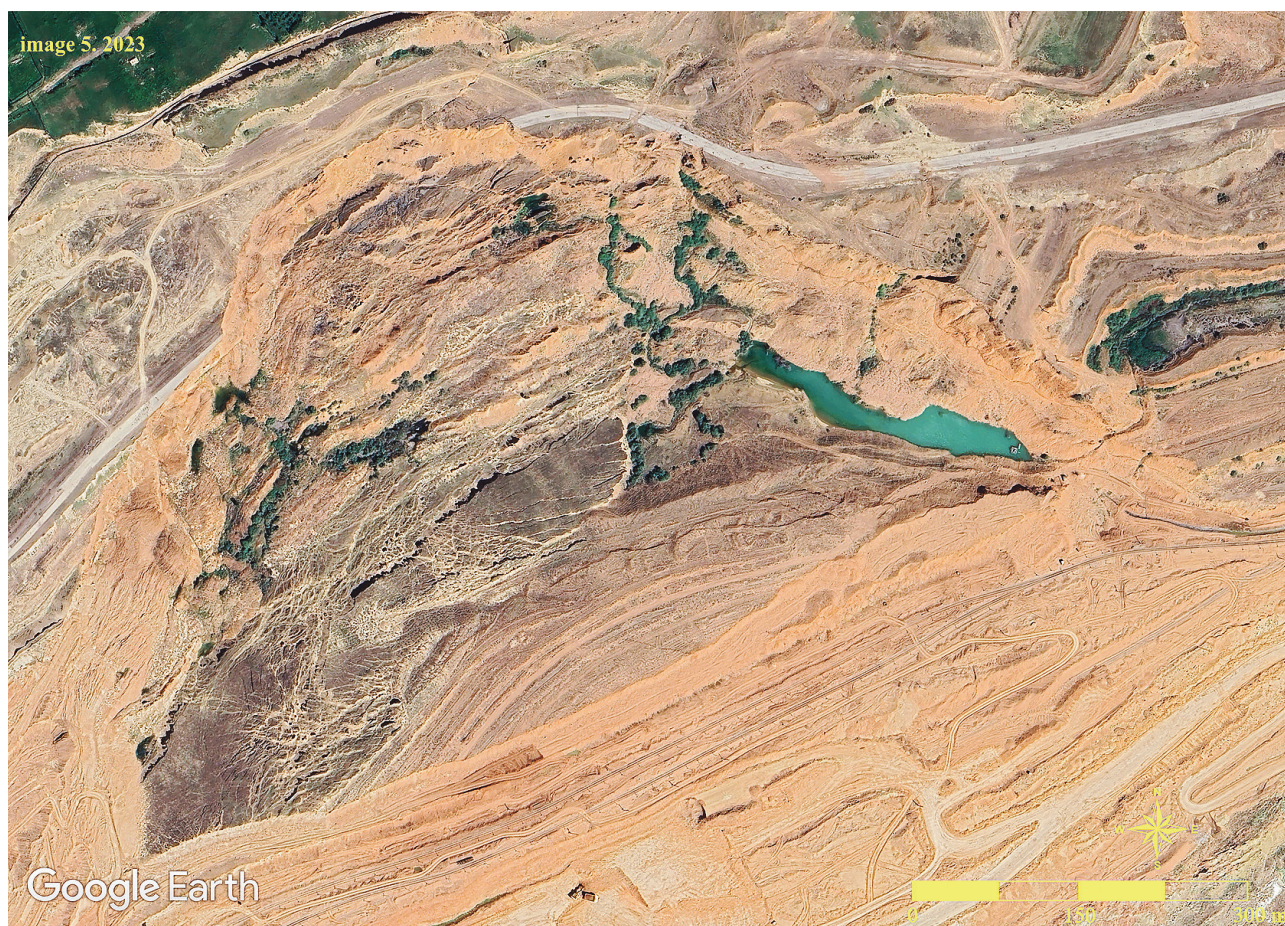
Fig. 15: Satellite image of the „Staraja Podstanciya“ landslide. This image is dated May 2, 2023.

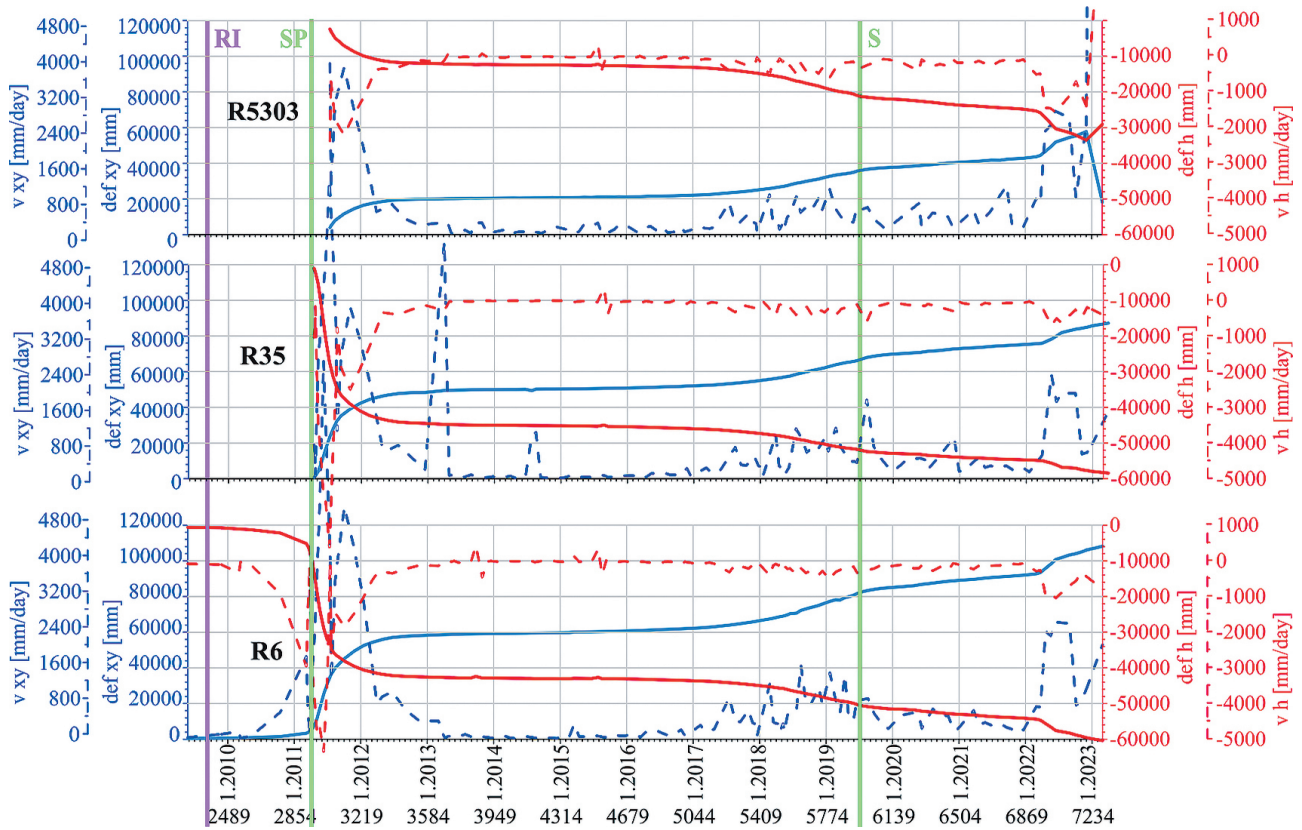
Fig. 16: Results of geodetic measurements (deformation and speed of movement) of selected points on the „Staraya Podstanciya“ landslide (geodetic points see Fig. 5)

Fig. 16 depicts horizontal (in blue) and vertical (in red) deformations and the velocities of sliding of three points of the “Staraya Podstanciya” landslide. Below the pattern of each parameter, the positions of points 6, 35 and 5303 (Fig. 17) are depicted in the underprint along with the contour of the landslide. Points 5303 and 35 lie at the left and right-side crack, respectively, point 6 then in the centre of the landslide. By observing all curves, it can be found that no significant differences exist between the

movements of such points. It is clear that the greatest movements were just after the initial movement of the landslide. Then a period of resting followed, namely until the beginning of the year 2017 when the size of movement of the landslide again increased. Its cause was, in most likelihood, more extensive mining and preparatory work in the pit. Interesting is the movement of point 5303 in 2010. While the whole future landslide was not deformed in that year, point 5303 moved. Here, it is necessary to realise that in fact this point already lay on the moving landslide which was the “Centralny” landslide.
