# Efficiency of protective coating applied on a highly porous decorative tuff

Tatiana Durmeková, Renáta Adamcová, Martin Maľa & Petra Grand

## AGEOS

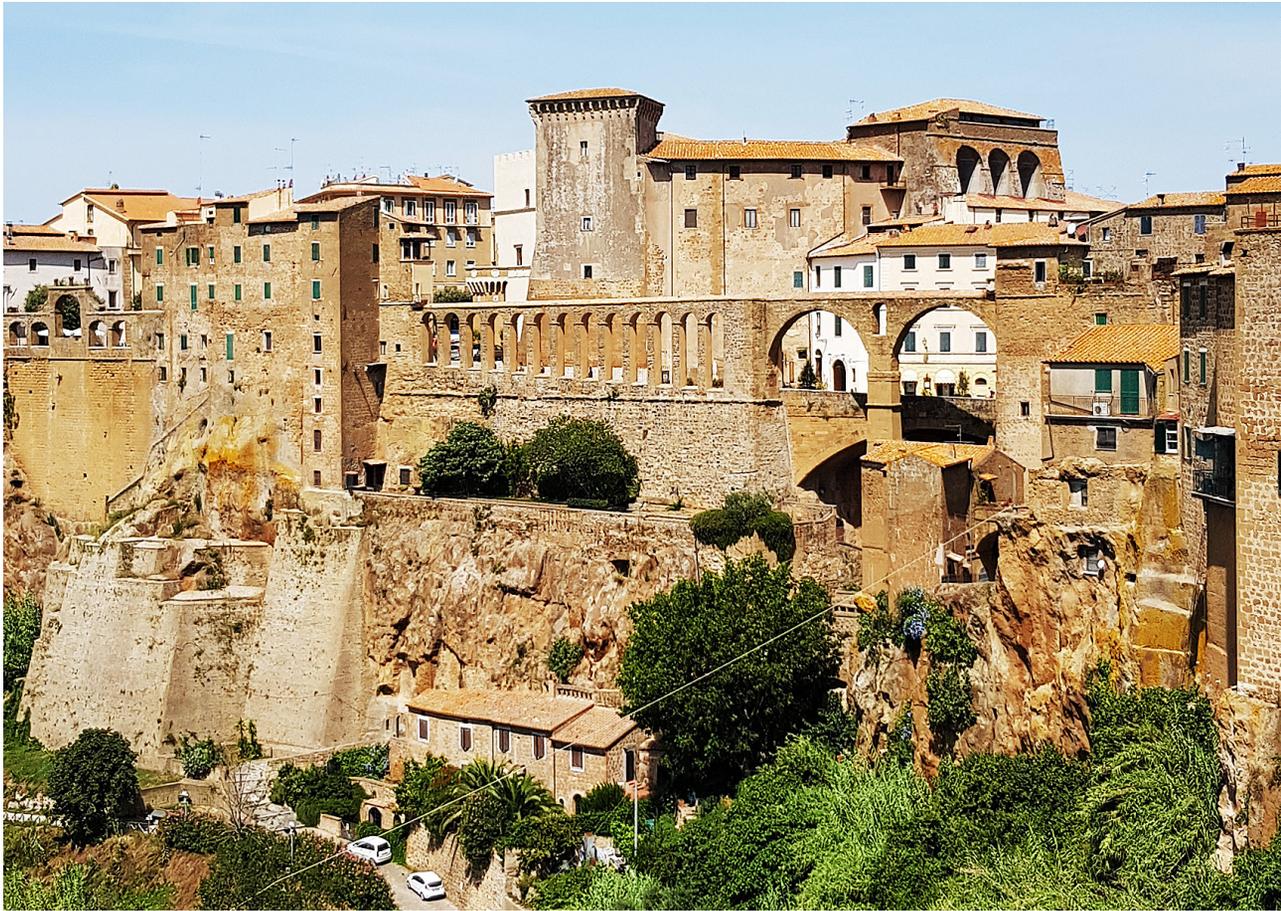
**Fig. 2:** Selective weathering of the tuff facades is less evident from the distance; a walk in the historic center of Pitigliano reveals the building stone decay (Mantu A., <https://pixabay.com>, free download and use, 2021-03-21).

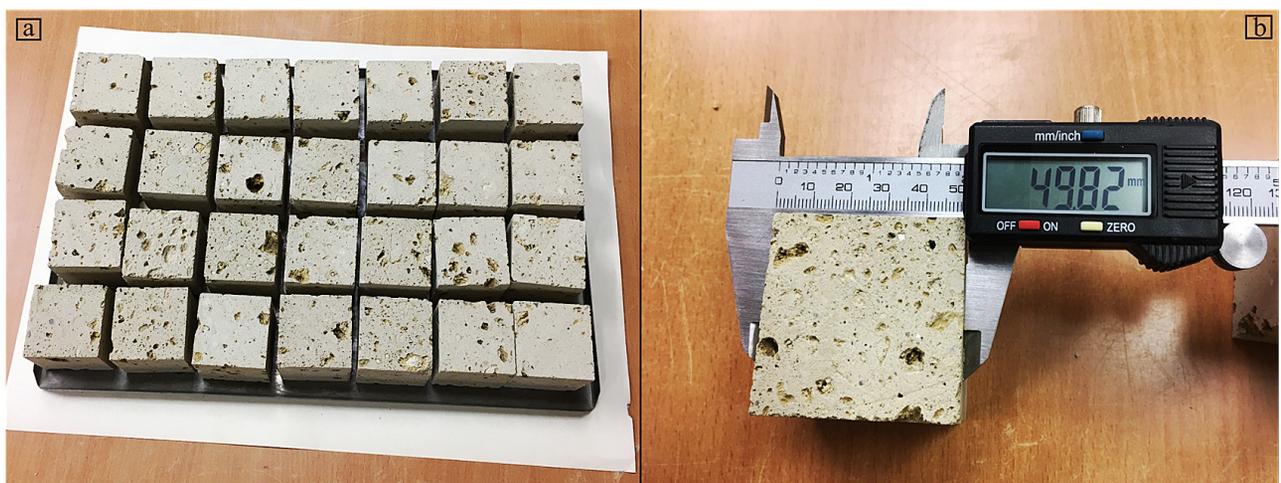
**Fig. 3:** Tuff samples. a – one part of the tuff cubes prepared for the application of the protective coating; b – a more detailed view of the tuff showing the remarkable macro-porosity.

One commercial supplier intended to bring this natural stone to the building material market in Slovakia. He offered and delivered the tuff for the laboratory research in the form of rock monoliths measuring approximately 30 cm x 20 cm x 20 cm. Test samples were produced from monoliths by cutting, using parallel saws. More than 70 test samples in the shape of cubes with the edge length of approximately 50 mm were prepared (Fig. 3).

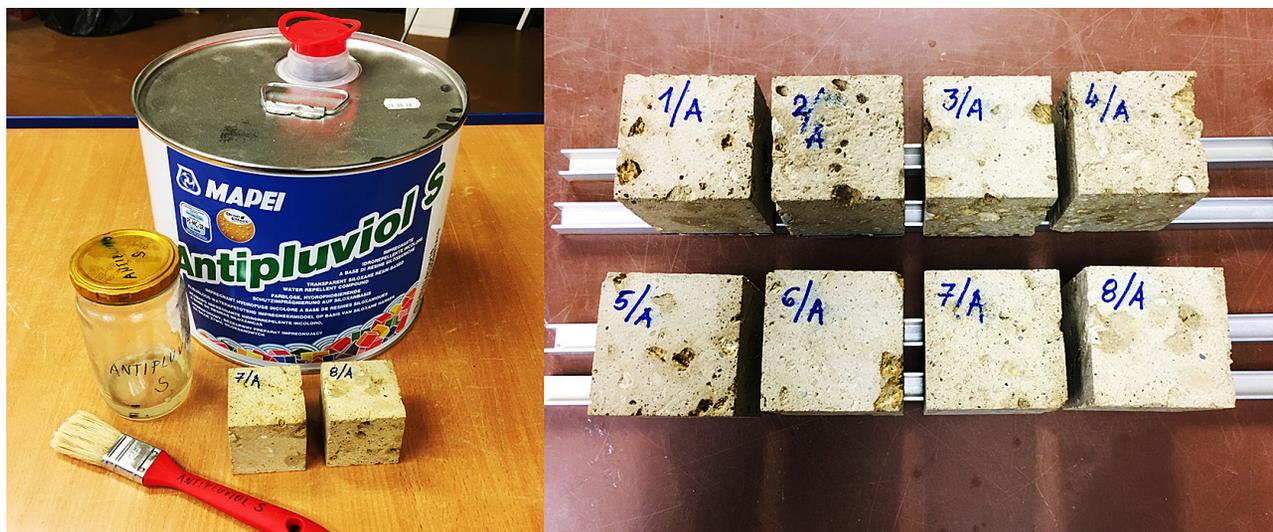
Fig. 4: Tuff samples impregnated by the protective coating Antipluvioi S.

One portion of the prepared tuff cubes was treated with a protective coating Antipluviol S: 3 samples for the *WAC* test, 6 samples for *WAI* and the following frost resistance tests. The coating was applied twice, to the entire surface of the test cubes, with a flat brush, according to the producer's recommendation, at least two hours apart (Fig. 4).

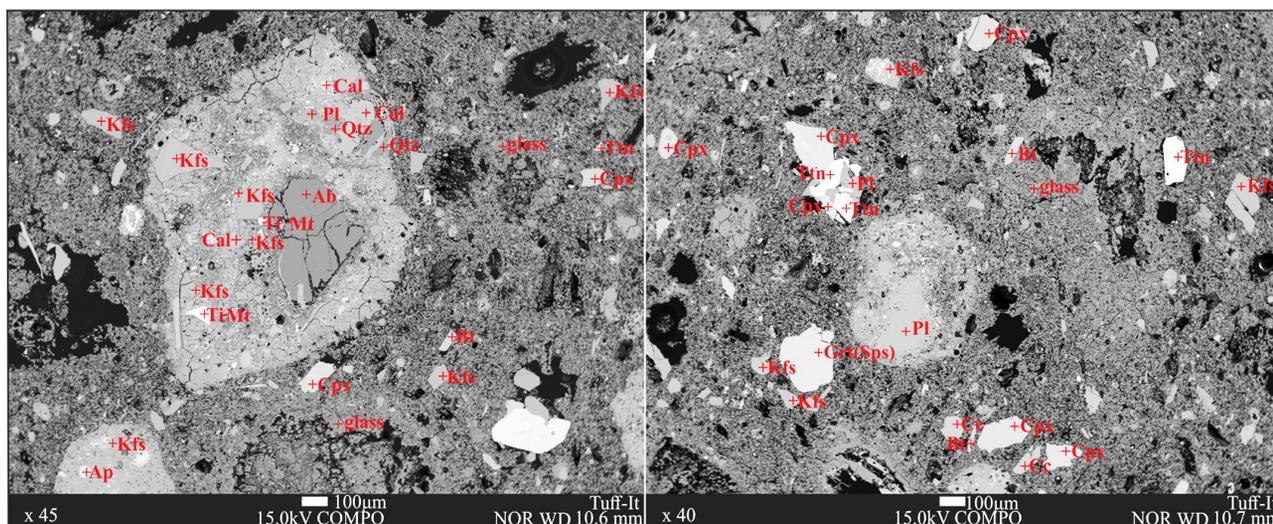
Fig. 5: Minerals identified by EPMA microphotos in the untreated tuff. Kfs – potassium feldspar, Pl – plagioclase, Qtz – quartz, Cal – calcite, Ttn – titanite, Cpx – clinopyroxene, Ap – apatite, Ab – albite, Bt – biotite, Ti-Mt – titaniferous magnetite, Grt(Sps) – spessartine garnet.

The mineral composition of the tuff proved to be very varied. Except for the volcanic glass, which forms the rock matrix, minerals as quartz, potassium feldspar, plagioclase, biotite, calcite, apatite, albite, clinopyroxene, titanite, titaniferous magnetite, spessartine were identified (Fig. 5). Rock fragments and rests of the juvenile

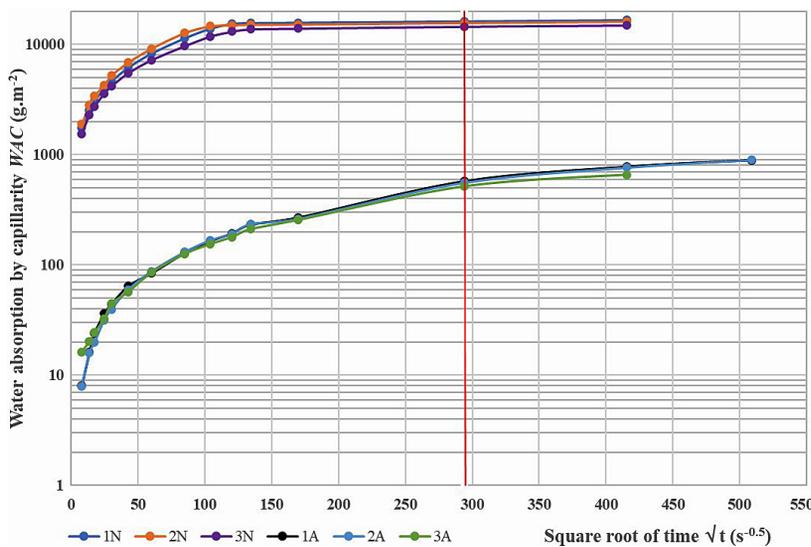
**Fig. 6:** Representative water absorption curves by capillarity. N – natural samples, A – samples coated with Antipluviol S, red line –  $t = 1440$  min.

WAC testing has proven to be a very suitable method for the evaluation of the efficiency of the protective coating of the natural stone. This statement can be documented by the mean values of WAC and by the diametrically different time-related absorption curves of the untreated and treated tuff samples (Fig. 6). Significant differences are visible between the values of the absorption coefficient  $C_f$  (Fig. 7, Tab. 3) that were calculated from the absorption curves. Performed tests have shown that the protective coating Antipluviol S had a significant effect on WAC.

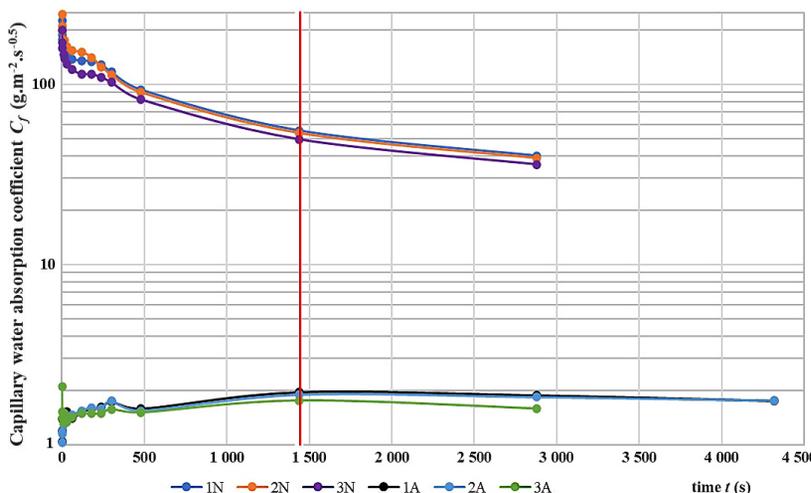
**Fig. 7:** Capillary water absorption coefficient in time relation. N – natural samples, A – samples coated with Antipluviol S, red line –  $t = 1440$  min.

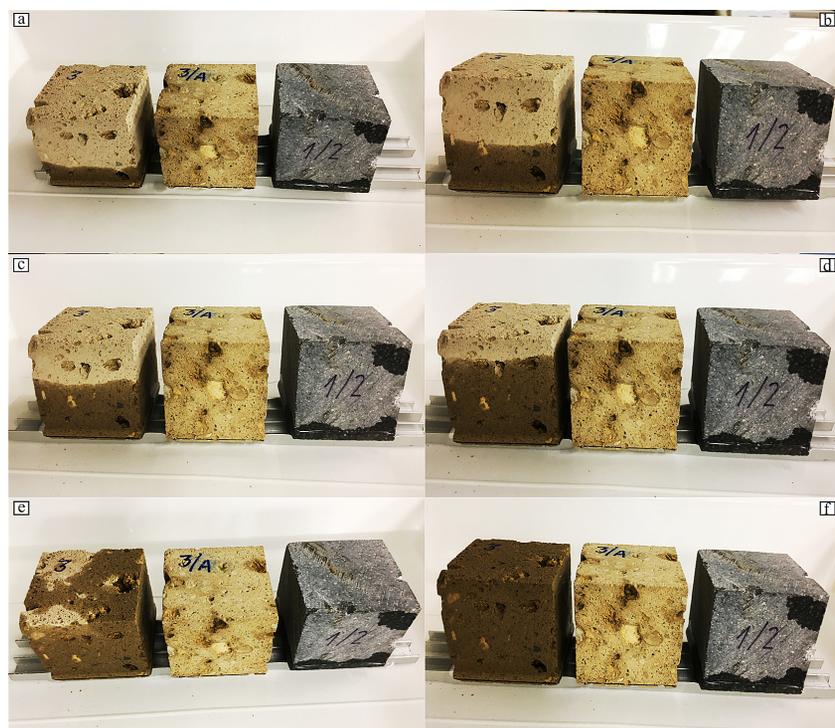
**Fig. 8:** Progress of the water absorption by capillarity over time is evident from the colour change of the saturated part in the yellowish tuff samples (compared to a grey low-porosity andesite as a contrast). a – after 10 minutes, b – after 30 minutes, c – after 60 minutes, d – after 2 hours, e – after 3 hours, f – after 4 hours. Explanatory notes: the first cube from left to right is an untreated sample in all photos; the second one is the sample coated by Antipluviol S.

Photographs in Fig. 8 document the very high capillary water absorption potential of studied tuffs in their untreated natural

state and the efficiency of the used protective coating. The difference in the visual appearance of the samples treated and untreated with Antipluviol S and immersed in water is evident from Fig. 9. While the untreated sample looks dark and fully saturated at the end of the test, the appearance of the coated samples with Antipluviol S remains unchanged, seemingly dry.

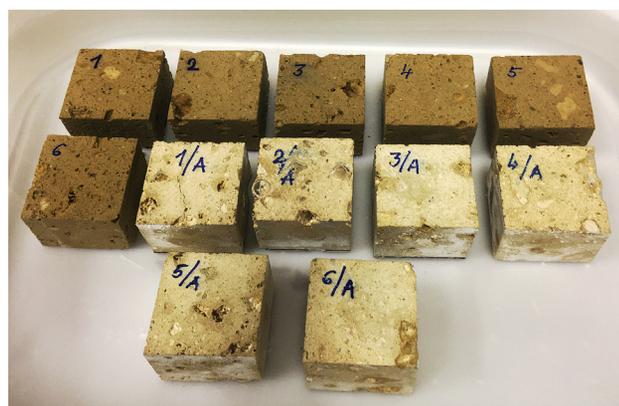
**Fig. 9:** Macroscopically visible differences between the untreated specimens (No. from 1 to 6) and impregnated ones (No. from 1/A to 6/A) immersed in water.
